Lessons to be learned

Life boat test – near casualty

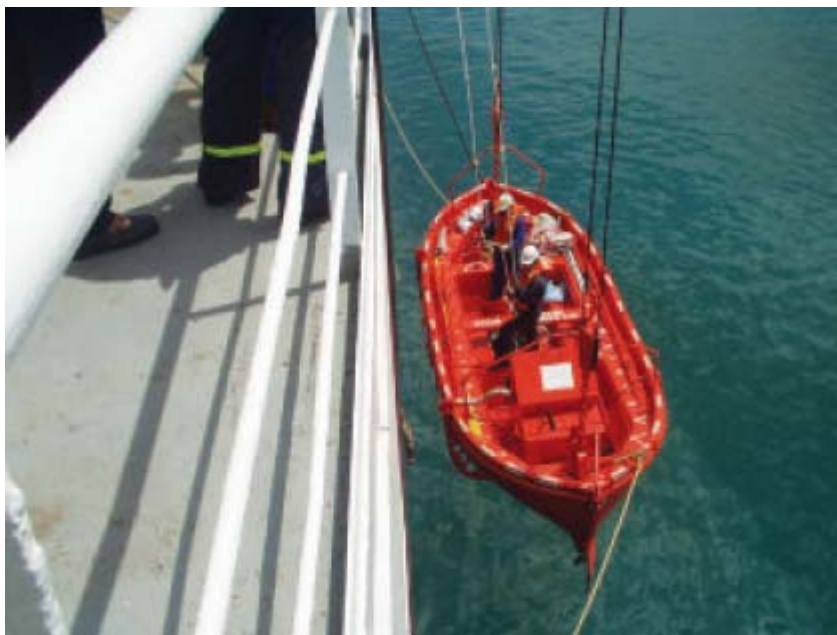
During re-hooking of the lifeboat after the launching test in connection with the Safety Equipment Certificate survey, extensive movements of the lifting blocks and falls were encountered due to heavy swell and current. Hoisting of the lifeboat was commenced by the mechanically operated davit winch. A strange “jumping” and “unbalance” between the forward and aft wire falls were soon noticed. The hoisting operation was stopped when the lifeboat was about halfway up and it was noticed that the aft wire had escaped from the upper sheave and was jammed between the sheave and the block body. The lifeboat was then secured with extra wires and chain blocks and the crew was taken safely on board the ship again by rope ladder and safety belts. The aft wire was released. The wire, sheave and block were thoroughly examined and refitted. The boat was safely raised to the stowed position.

This picture is for illustration purposes only (note: calm sea)

It was likely that the sea condition, with heavy swell and current, caused the aft wire fall to escape from the upper sheave due to the extensive movement of the lifting blocks and falls during the re-hooking operation. This situation was discovered only after hoisting the lifeboat about halfway up to its secured position.

- Before the test starts a thorough examination of the lifeboat, davits, wires, sheaves, block etc. is strongly recommended.
- Before starting a lifeboat test, the sea conditions are to be considered for safe launching and recovery

- During recovery of the lifeboat the following should be considered:
 - Lift the lifeboat about one meter above the water level and stop the winch.
 - Confirm by visual inspection or communication with lifeboat crew that hooks, securing pins, sheaves blocks, wires etc. are in correct position before recovery is completed.

- Whenever any strange behaviour to equipment or in test performance is noticed, the test should be stopped immediately and a thorough check of vital parts should be carried. The test should not commence until the problem is detected and solved.
