Lessons to be learned

Reefer vessel - Condenser failure resulting in total system breakdown

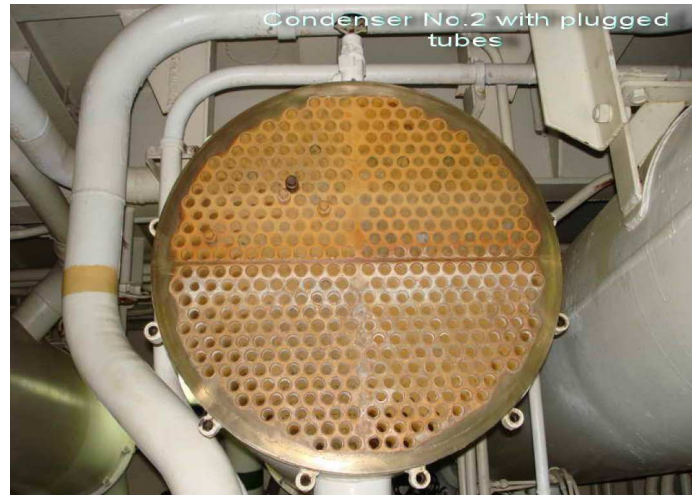
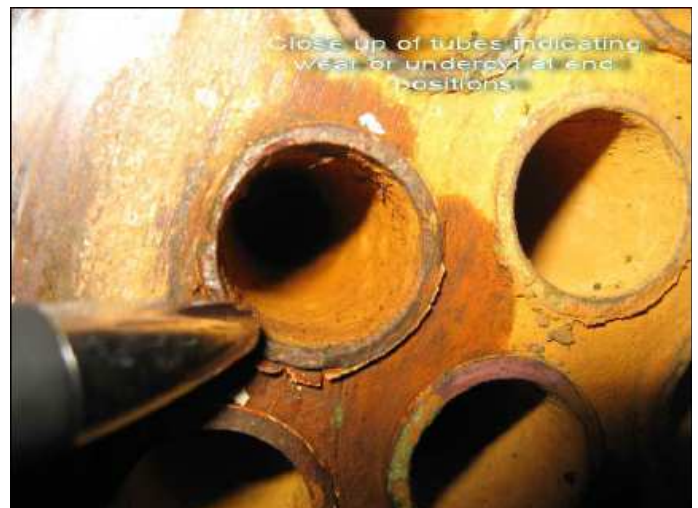
Managers of the vessel sent out reefer assistance and it was found that water had leaked into the Freon system inside the condenser, most likely due to fractured or punctured piping.

The condition of condensers can be regularly assessed by opening the water and freon covers, preferably every three to six months, to monitor the condition of the anti-corrosion anodes and, beyond a certain age, to check the condition of the tubes by, for instance, eddy current testing. Should repeated problems with condensers or deterioration of the condenser tubes / plates occur, timely replacement of the condensers should be considered.
